EGT 396

Project II: Repair Piece

Repairing the windshield wiper switch in a "96 Honda Civic.

The issue: Arm falls down, no longer centering itself, causing wipers to run constantly

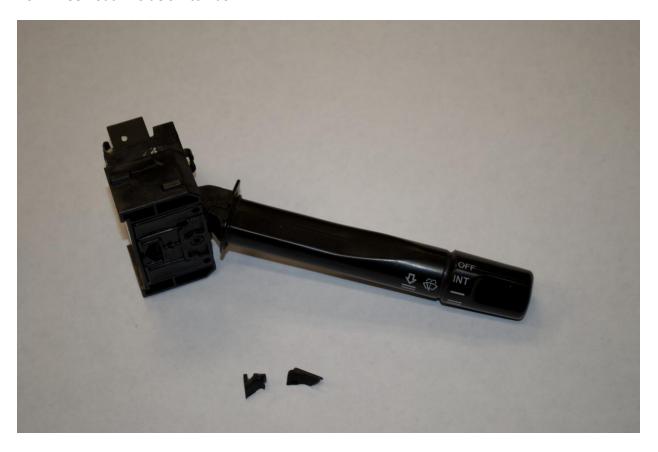
Problem located: The front face of the switch box has a bevelled portion that causes a spring loaded rod to center the switch. This portion has broken into three pieces. The arm can now "free float" inside switch box.

Figure 1: Windshield wiper switch as it sits in steering column. (Broken bits at the bottom)

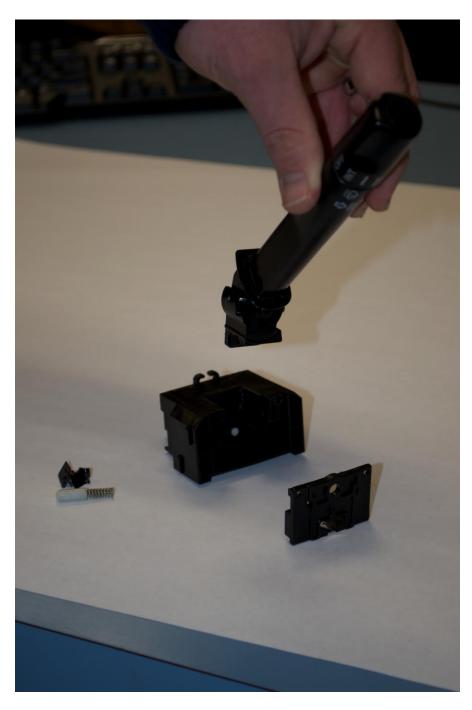
Figure 2: Switch assembly "Exploded View". Broken Pieces and spring rod off to the side.

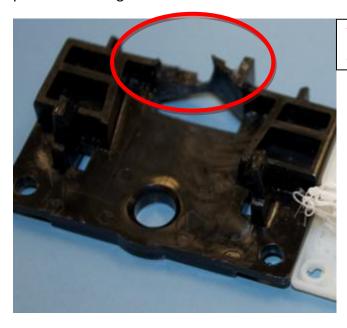
This area is less than .5mm thick at the thinnest point

Analysis: Try to find possible areas to "beef up" the front face of the bracket in order to prevent breaking in the future.
