# Equine Colic

## Ultrasound Examples

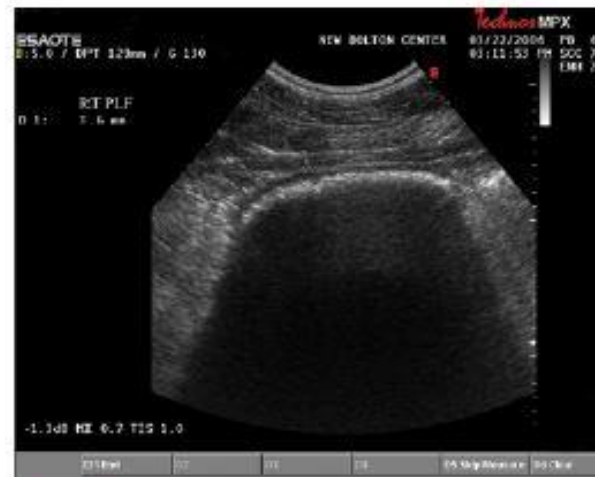
Figure 12.5 Cecal impaction. Image is obtained from right paralumbar fossa; dorsal is to the right. Note the echoic ingesta casting an acoustic shadow. Wall thickness is near normal at 3.6 mm.

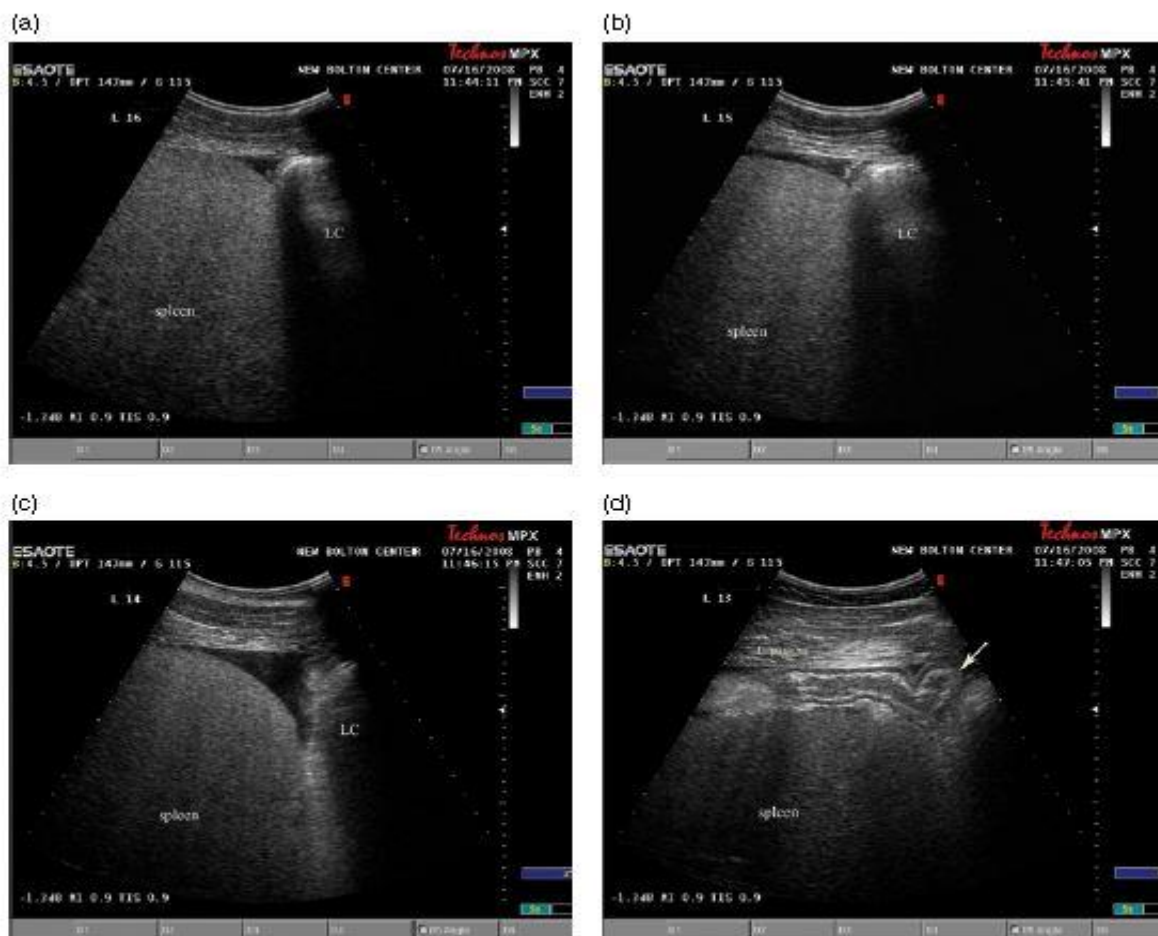
Figure 12.3 Left dorsal displacement with nephrosplenic entrapment. Images are obtained from the left 16th through the 13th intercostal spaces; dorsal is to the right. (a) Gas within the large colon (LC) creates a shadow over the dorsal aspect of the spleen preventing visualization of the left kidney. A small amount of fluid can be seen between the colon and the spleen. This appearance continues in the 15th (b) and 14th (c) intercostal spaces. (d) In the 13th intercostal space, a loop of small intestine (arrow) can be seen between the spleen and the diaphragm.

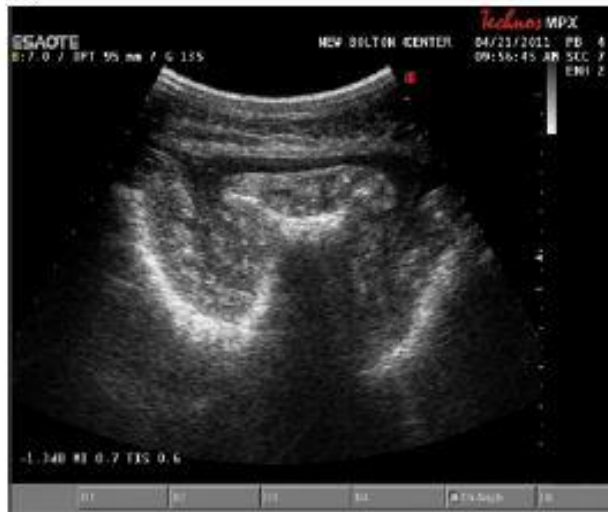
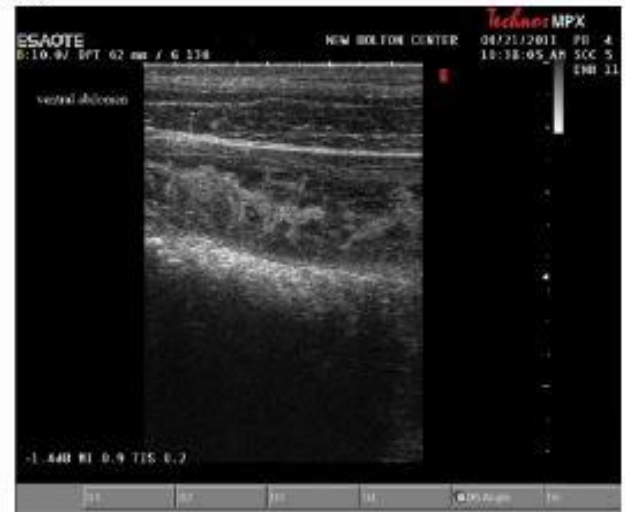
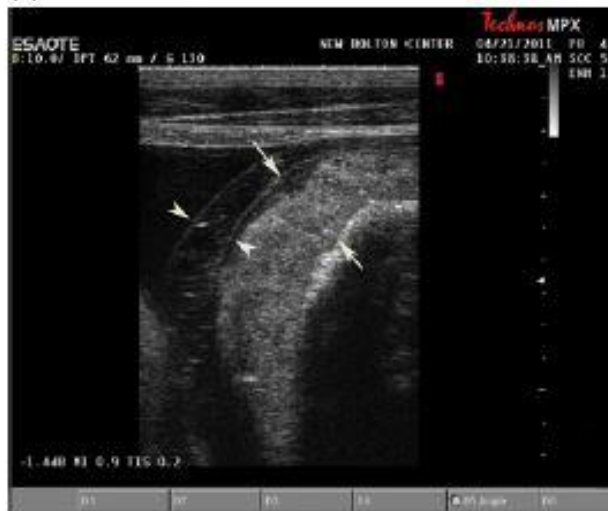
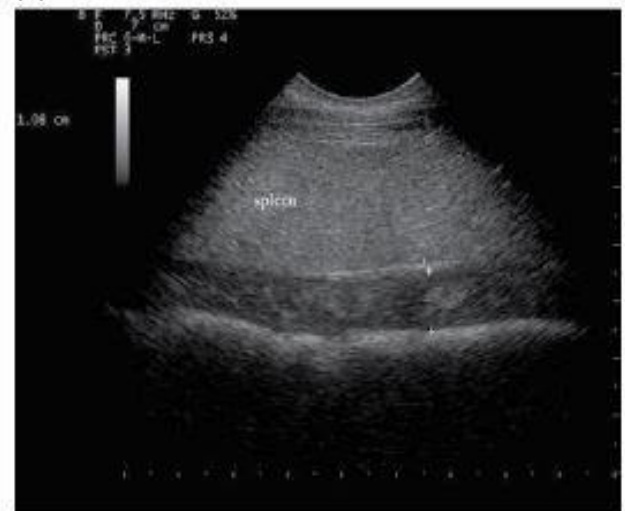
**Figure 12.4** Large colon volvulus. Images (a–c) are obtained from the ventral abdomen of a horse with acute onset of severe abdominal pain. (a) Note marked thickening and folding of the wall of the large colon. (b) High-frequency image shows the colon wall to be echoic with loss of normal layering. (c) Hypoechoic edematous mesentery (between arrowheads) can be seen along the echoic colon wall (between arrows). (d) Image obtained from ventral abdomen of horse with colitis. Note similar sonographic appearance to the colon wall with marked thickening (1.08 cm) and loss of layering.
